UH-1 MATERIEL MALFUNCTION/FAILURE MISHAP EXPERIENCE

1 July 1973 - 31 July 1977

Applied Research Division
Directorate for Technical Research and Applications

DOC 77-07

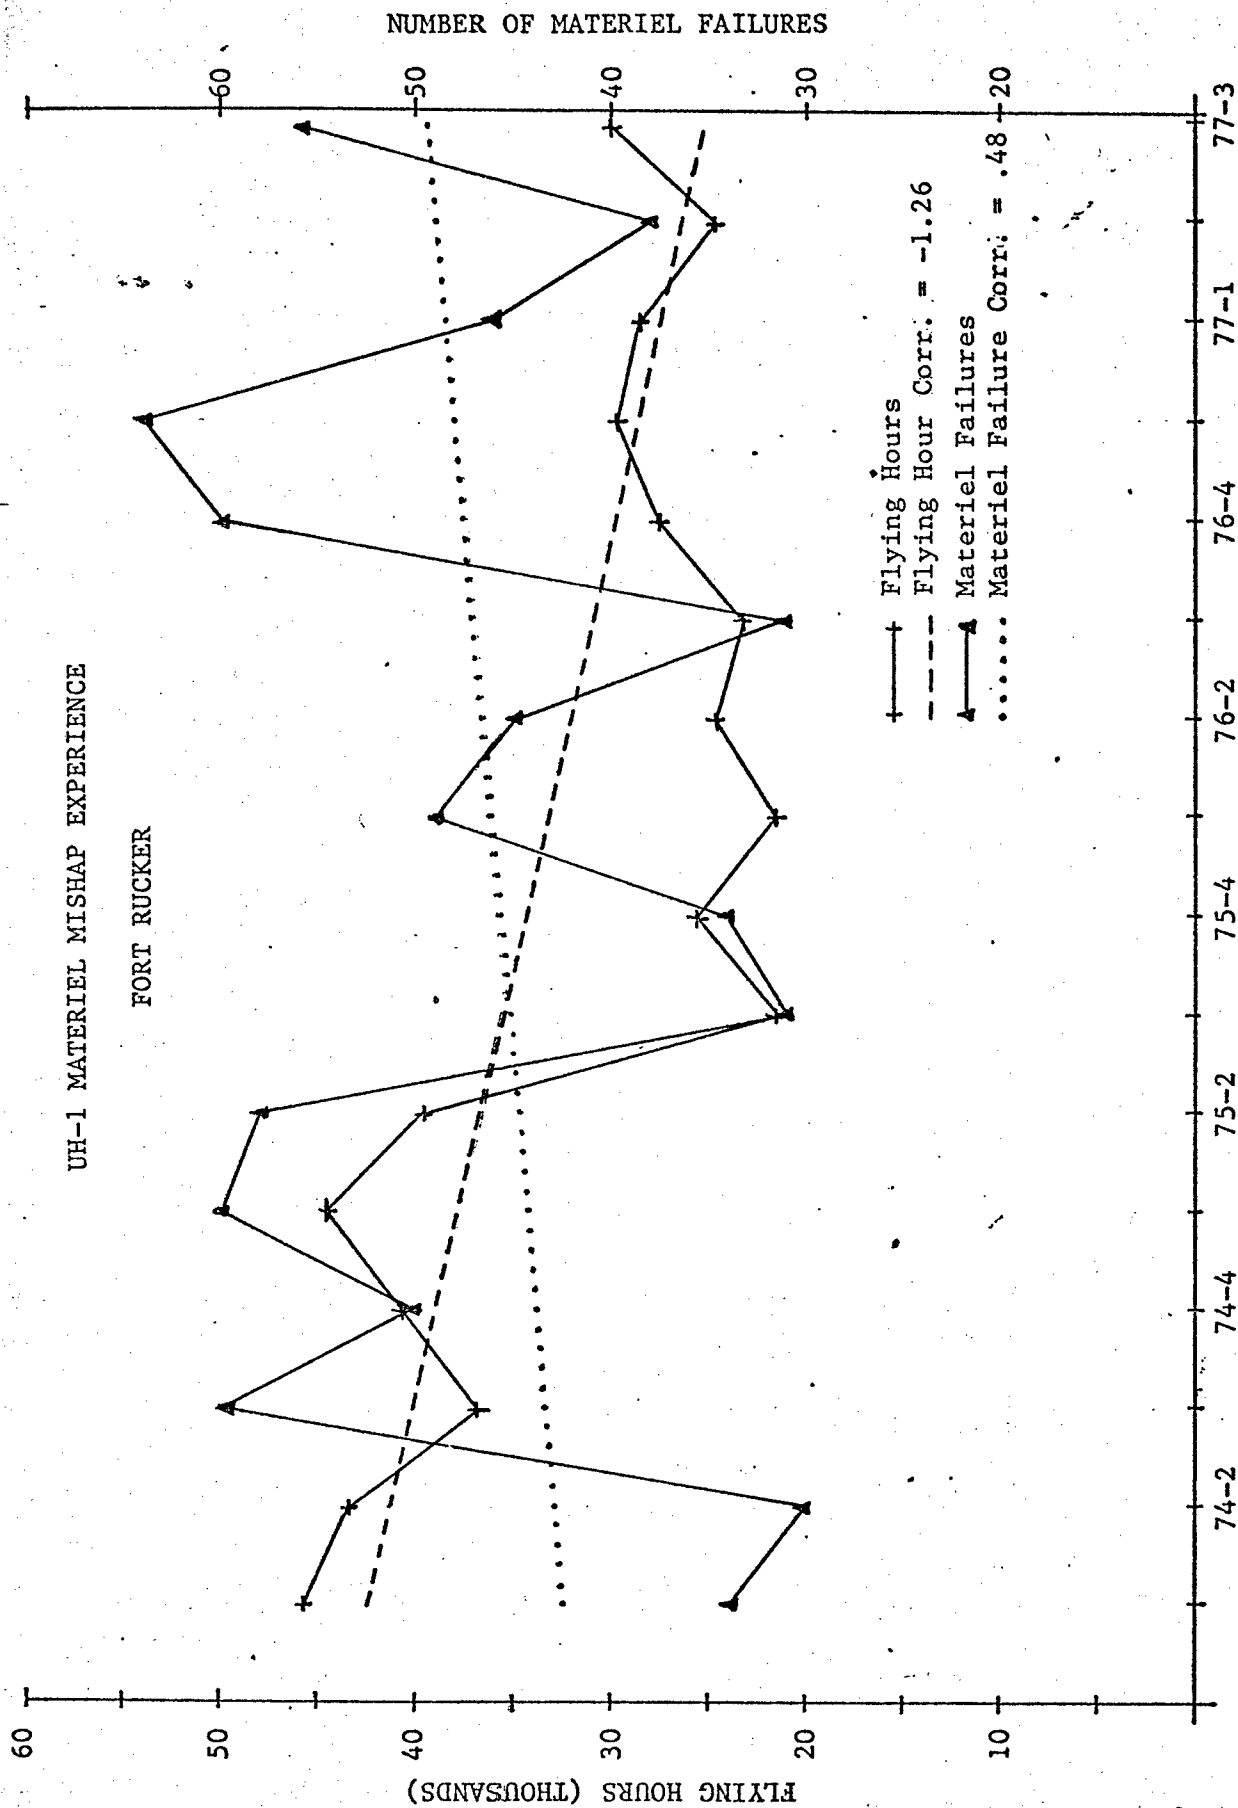
Figure 1

Figure 1, which compares the number of flying hours with the number of materiel caused mishaps by quarters at Fort Rucker, shows an increasing trend in materiel malfunctions/failures and a decreasing trend in flying hours.

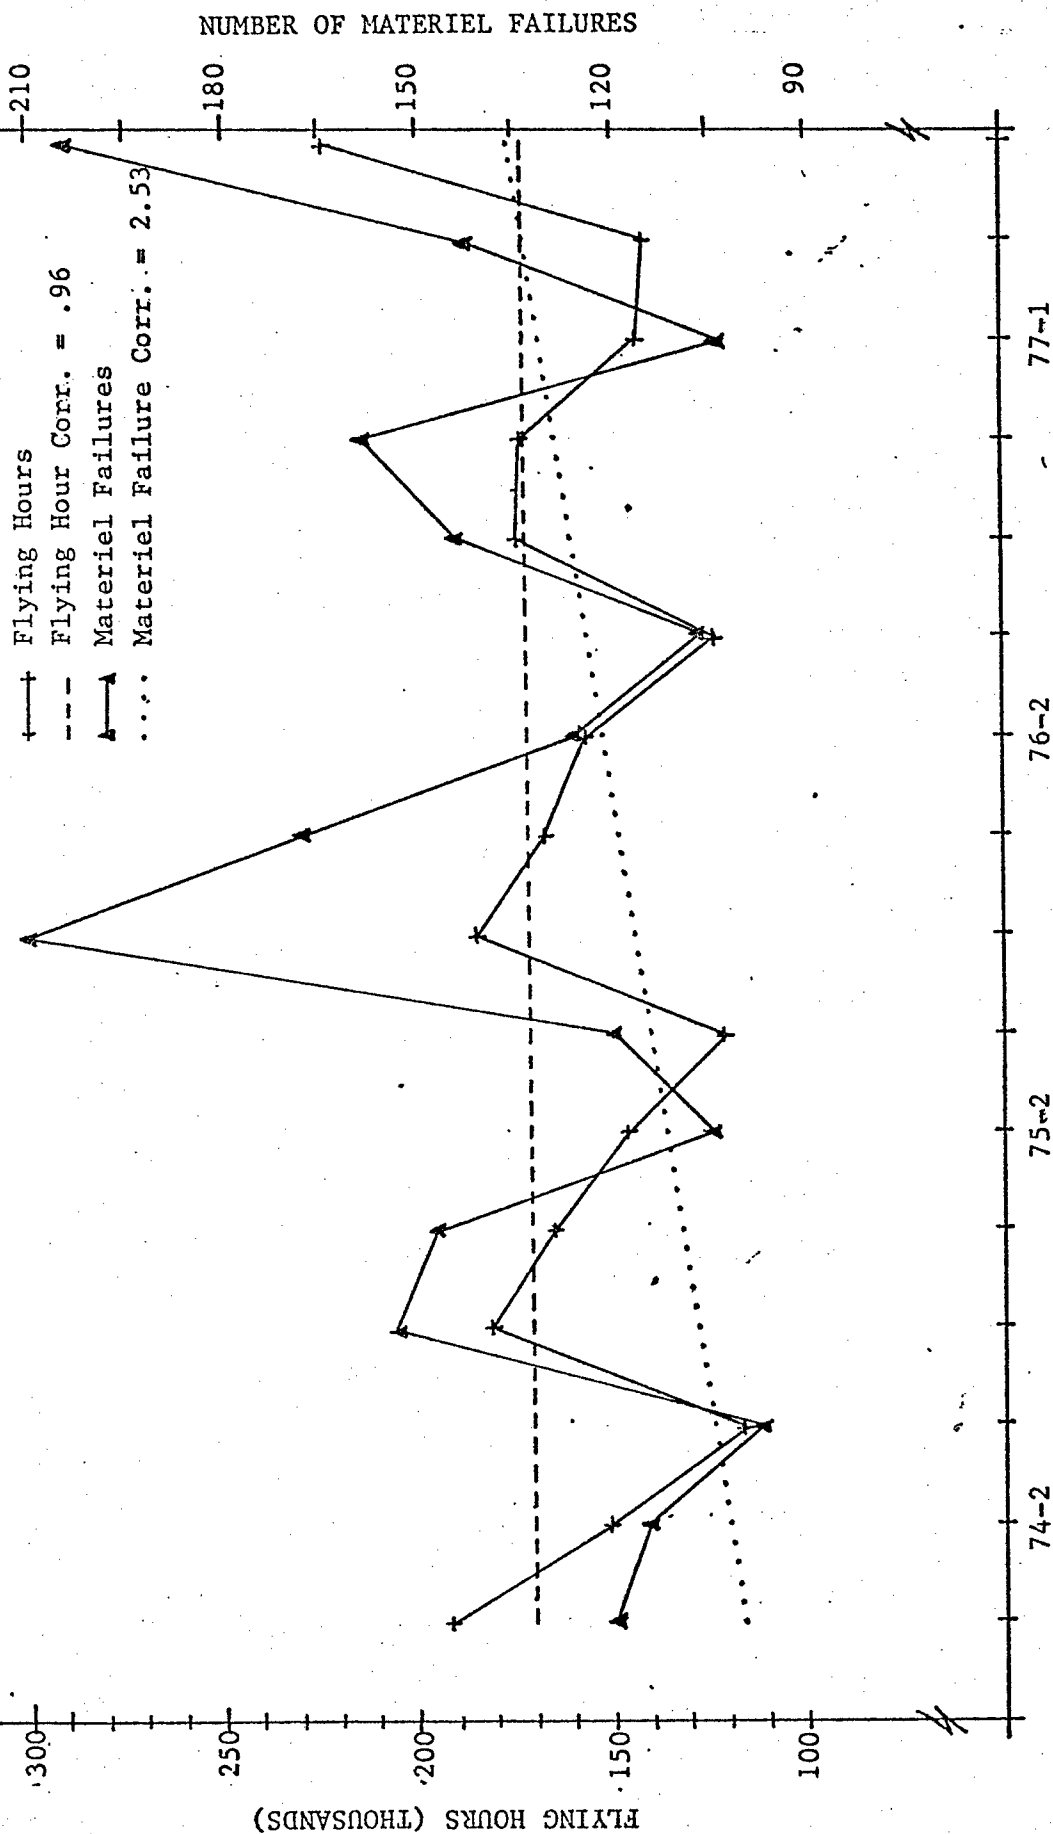
Figure 2 compares the number of flying hours with the number of materiel caused mishaps by quarters other than Fort Rucker. This figure shows an increasing trend in materiel malfunctions/failures and a steady trend in flying hours.

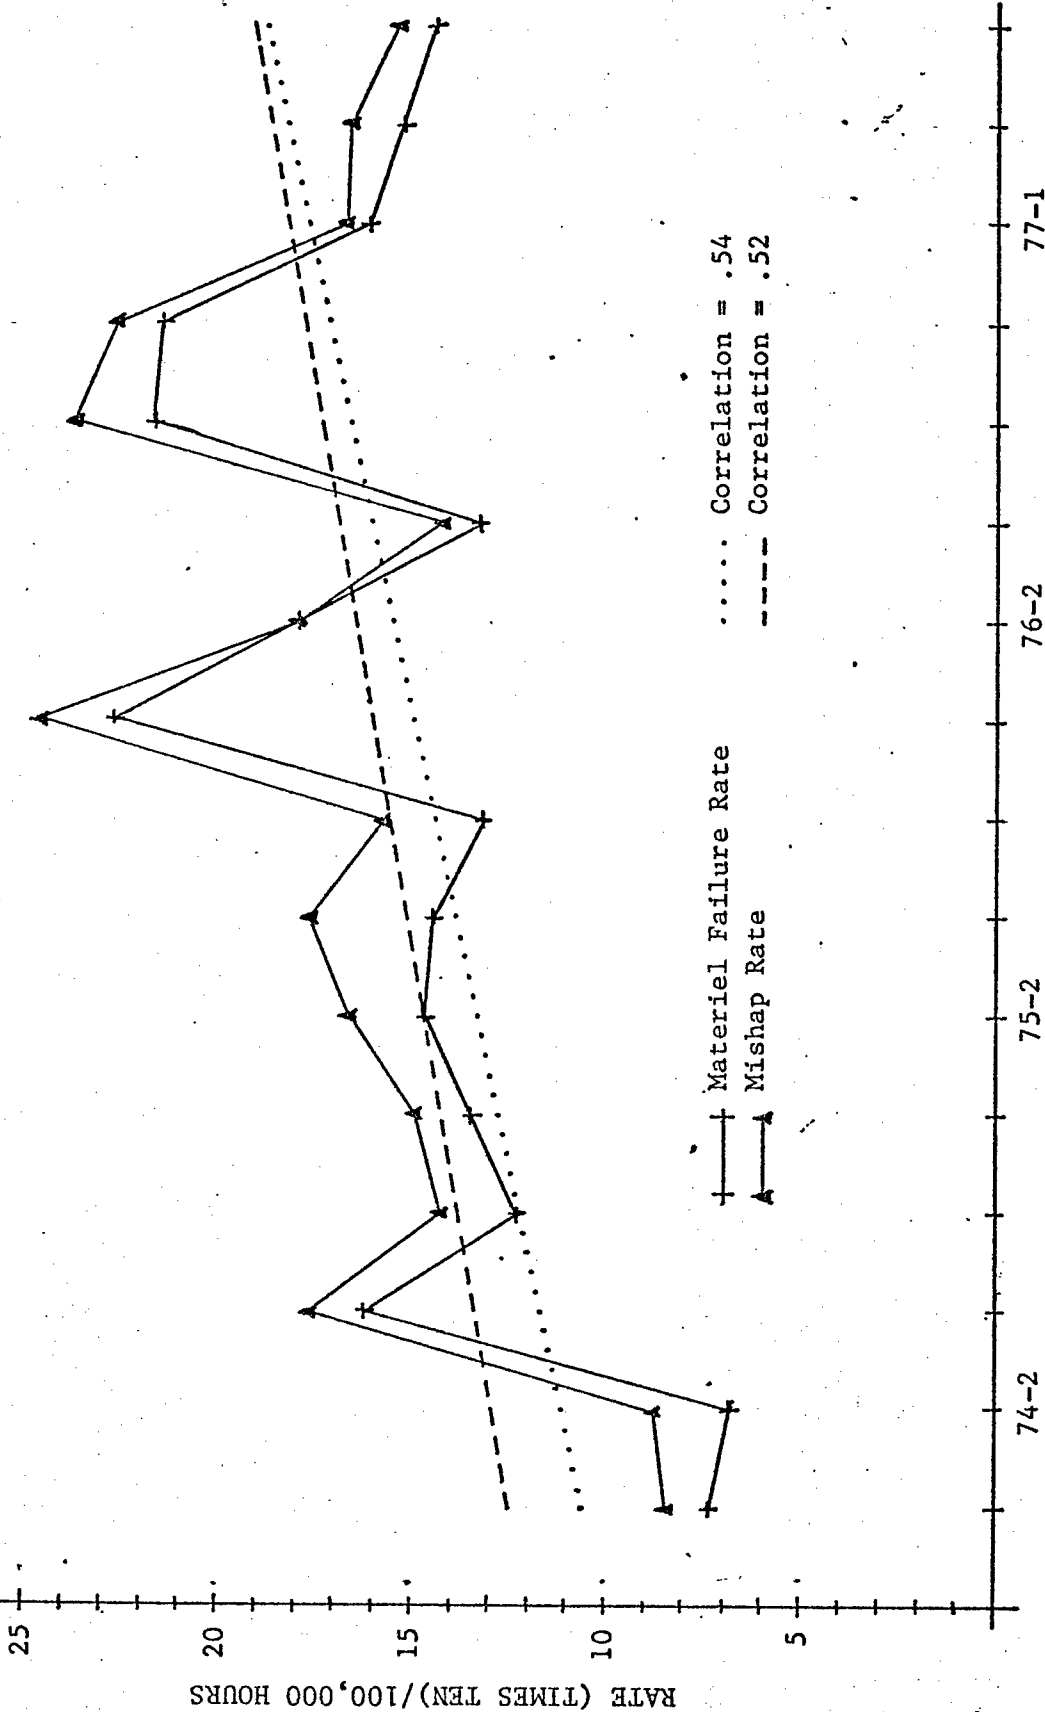
Figure 3 represents a comparison of the rates of materiel caused mishaps with total UH-1 mishaps at Fort Rucker. The trend lines show that the materiel caused mishaps are approaching the total mishaps. This indicates that while other causes are being reduced the materiel causes are increasing. The increasing trend is due largely to the electrical system, specifically the aircraft battery, malfunctions/failures in FY 76-4 and FY 7T and the hydraulic system in FY 76-1. The hydraulic system subsystems that caused the increase were the servo cylinders, a pressure switch and the irreversible valve.

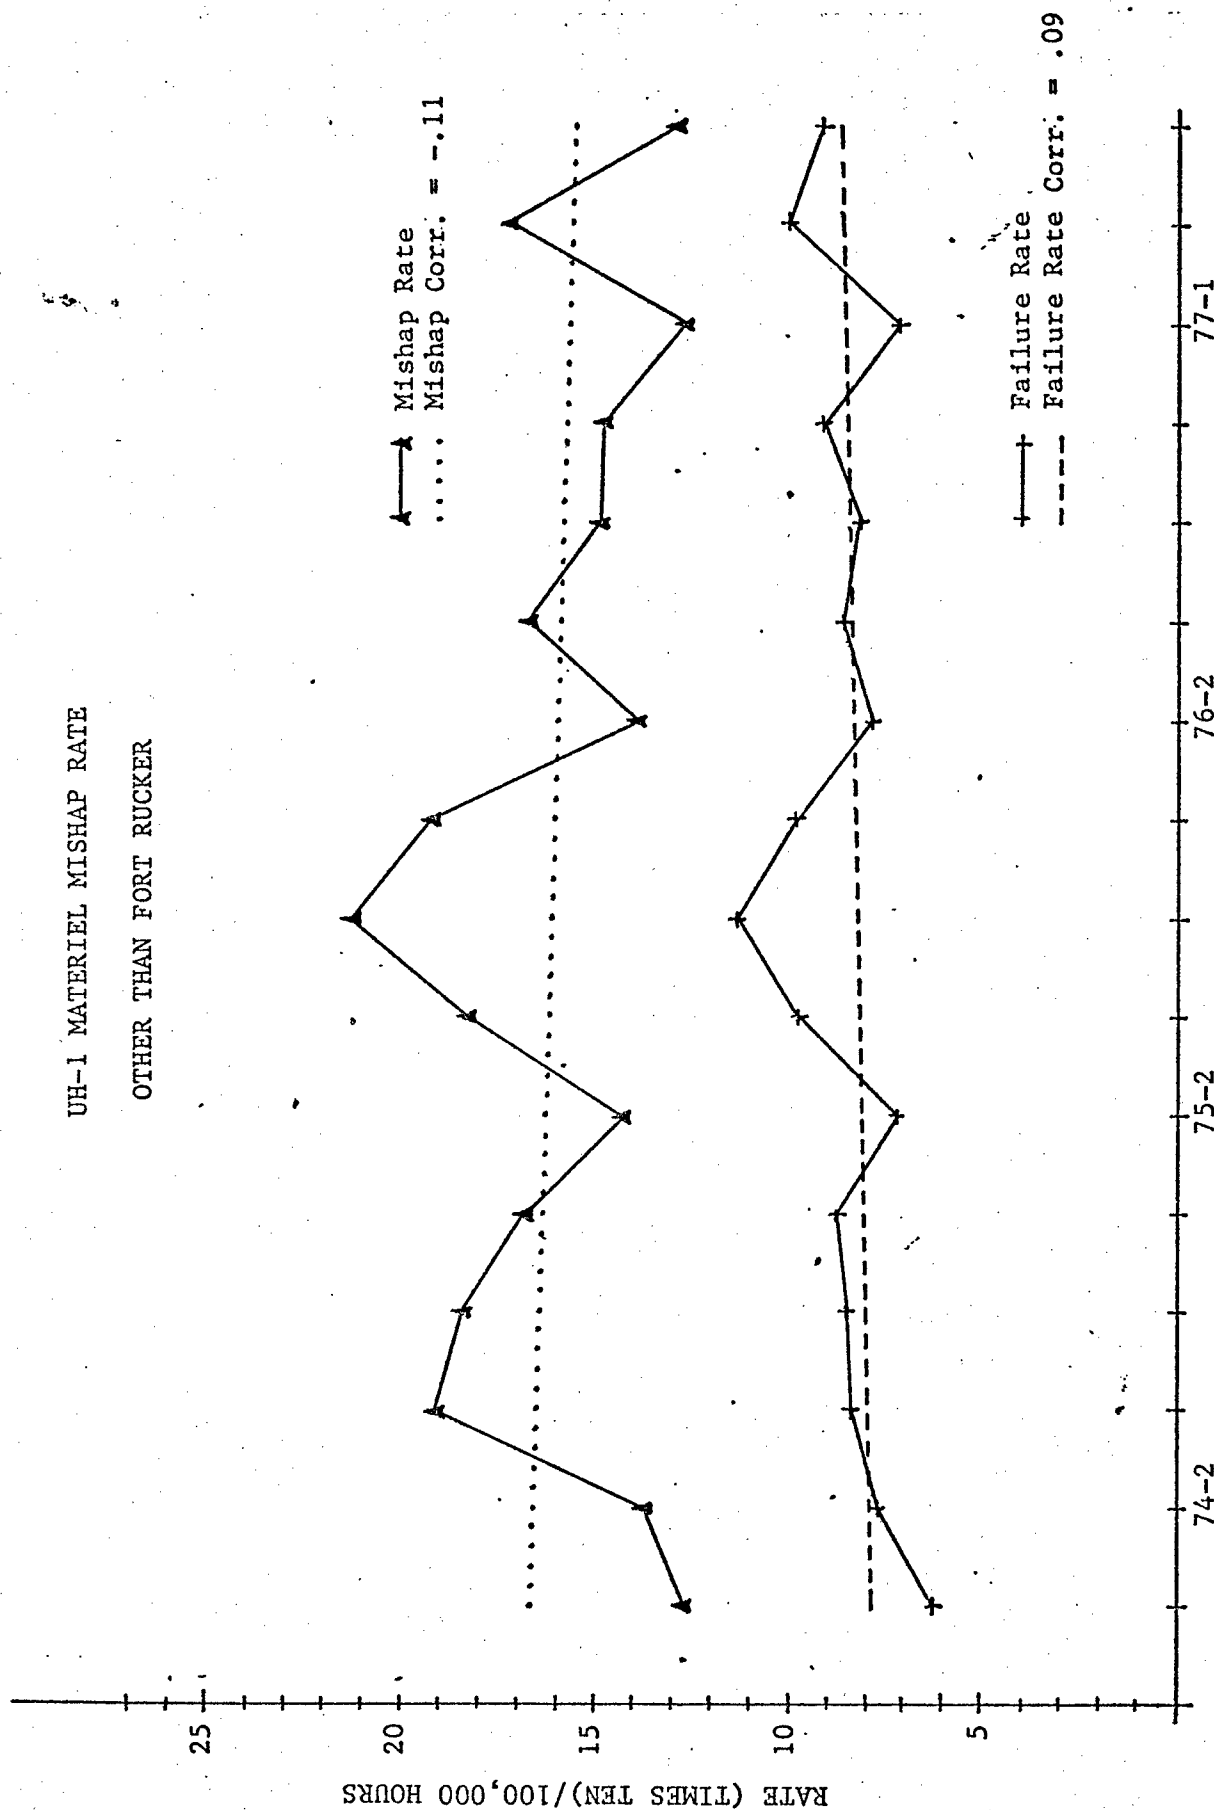
Figure 4 represents a comparison of the rates of materiel caused mishaps with total UH-1 mishaps other than Fort Rucker. The trend lines show that the materiel caused mishaps show an increase but are still well below that of total mishaps indicating that other cause factors have not been reduced.

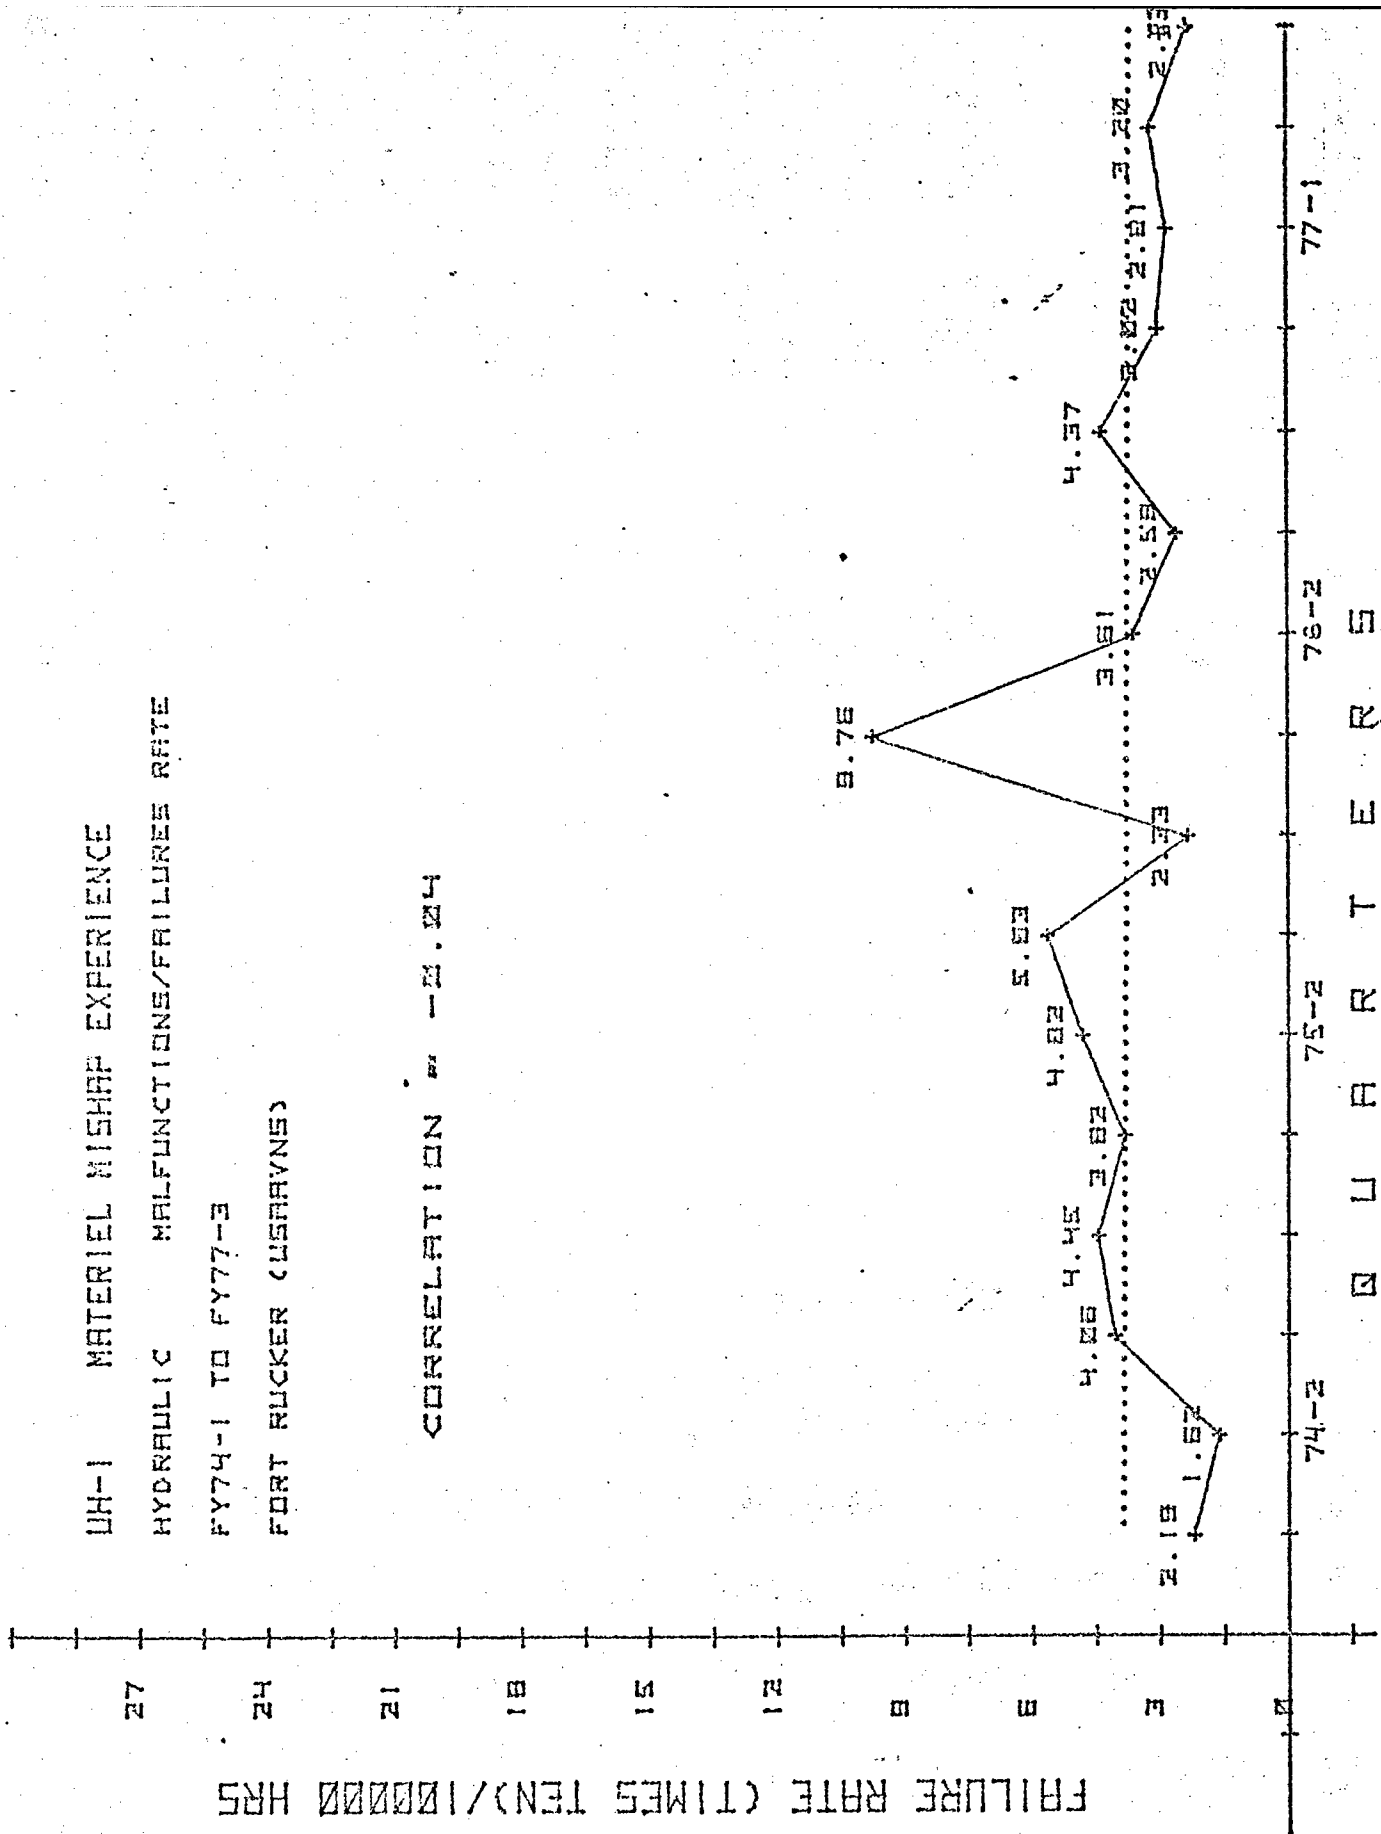
The hydraulic system malfunction/failures were the cause of 186 or 24.9% of the 746 UH-1 materiel caused mishaps. Figure 5 shows a very slight increasing trend over the study period, with the last four quarters showing a decline. The highest rate of 97.6/100,000 hours was achieved during first quarter FY 76. This large increase was due to increased malfunction/failure of the flight controls during this quarter. The

malfunctions/failures were in the pressure switch, the irreversible valve and the servo cylinders. The lowest rate occurred during 2nd quarter FY 74 of 16.2/100,000 hours. Hydraulic system materiel caused mishaps for the entire period occurred at a rate of 36.6/100,000 hours. This system accounted for 186 precautionary landings or 26% of the UH-1 materiel caused precautionary landings.

91 or 49% of the materiel caused hydraulic mishaps were a result of the malfunction/failure of a pressure switch (FSN 5930-00-646-3495). This represents 13% of the UH-1 materiel caused precautionary landings.

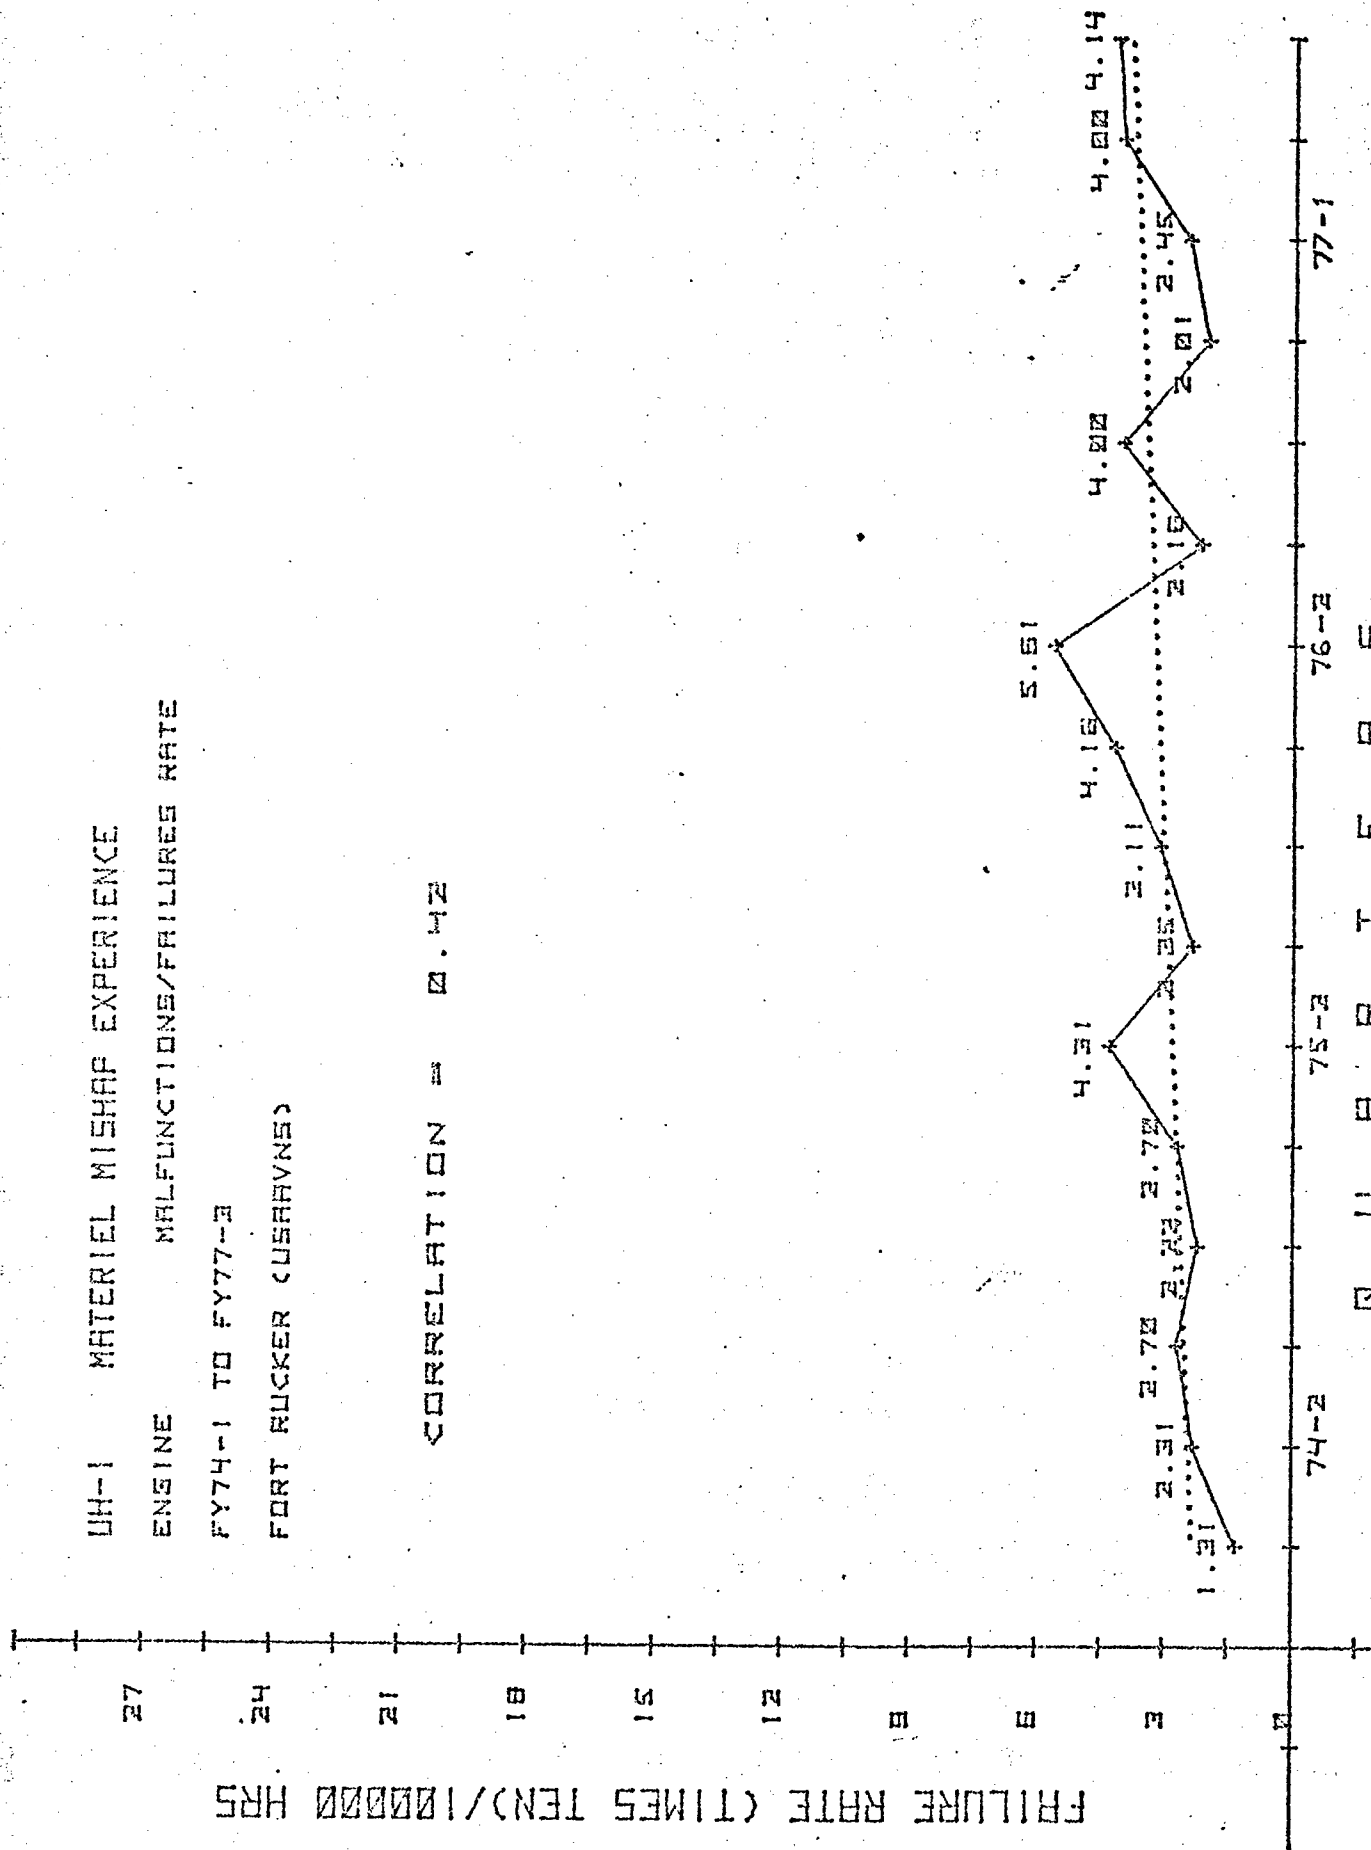
The engine/power plant system malfunctions/failures were the cause of 155 or 20.8% of the UH-1 materiel caused mishaps. Figure 6 shows a slight increasing trend over the study period. The highest rate of 56.1/100,000 hours occurred in 2nd quarter FY 76. The lowest rate of 20.1/100,000 was achieved in FY 7T. Engine/power plant system materiel caused mishaps, for the entire period, occurred at a rate of 30.5/100,000 hours. This system accounted for:

- 3 accidents or 43% of the UH-1 materiel caused accidents
- 1 incident or 17% of the UH-1 materiel caused incidents
- 14 forced landings or 100% of the UH-1 materiel caused forced landings
- 137 precautionary landings or 19% of the UH-1 materiel caused precautionary landings.

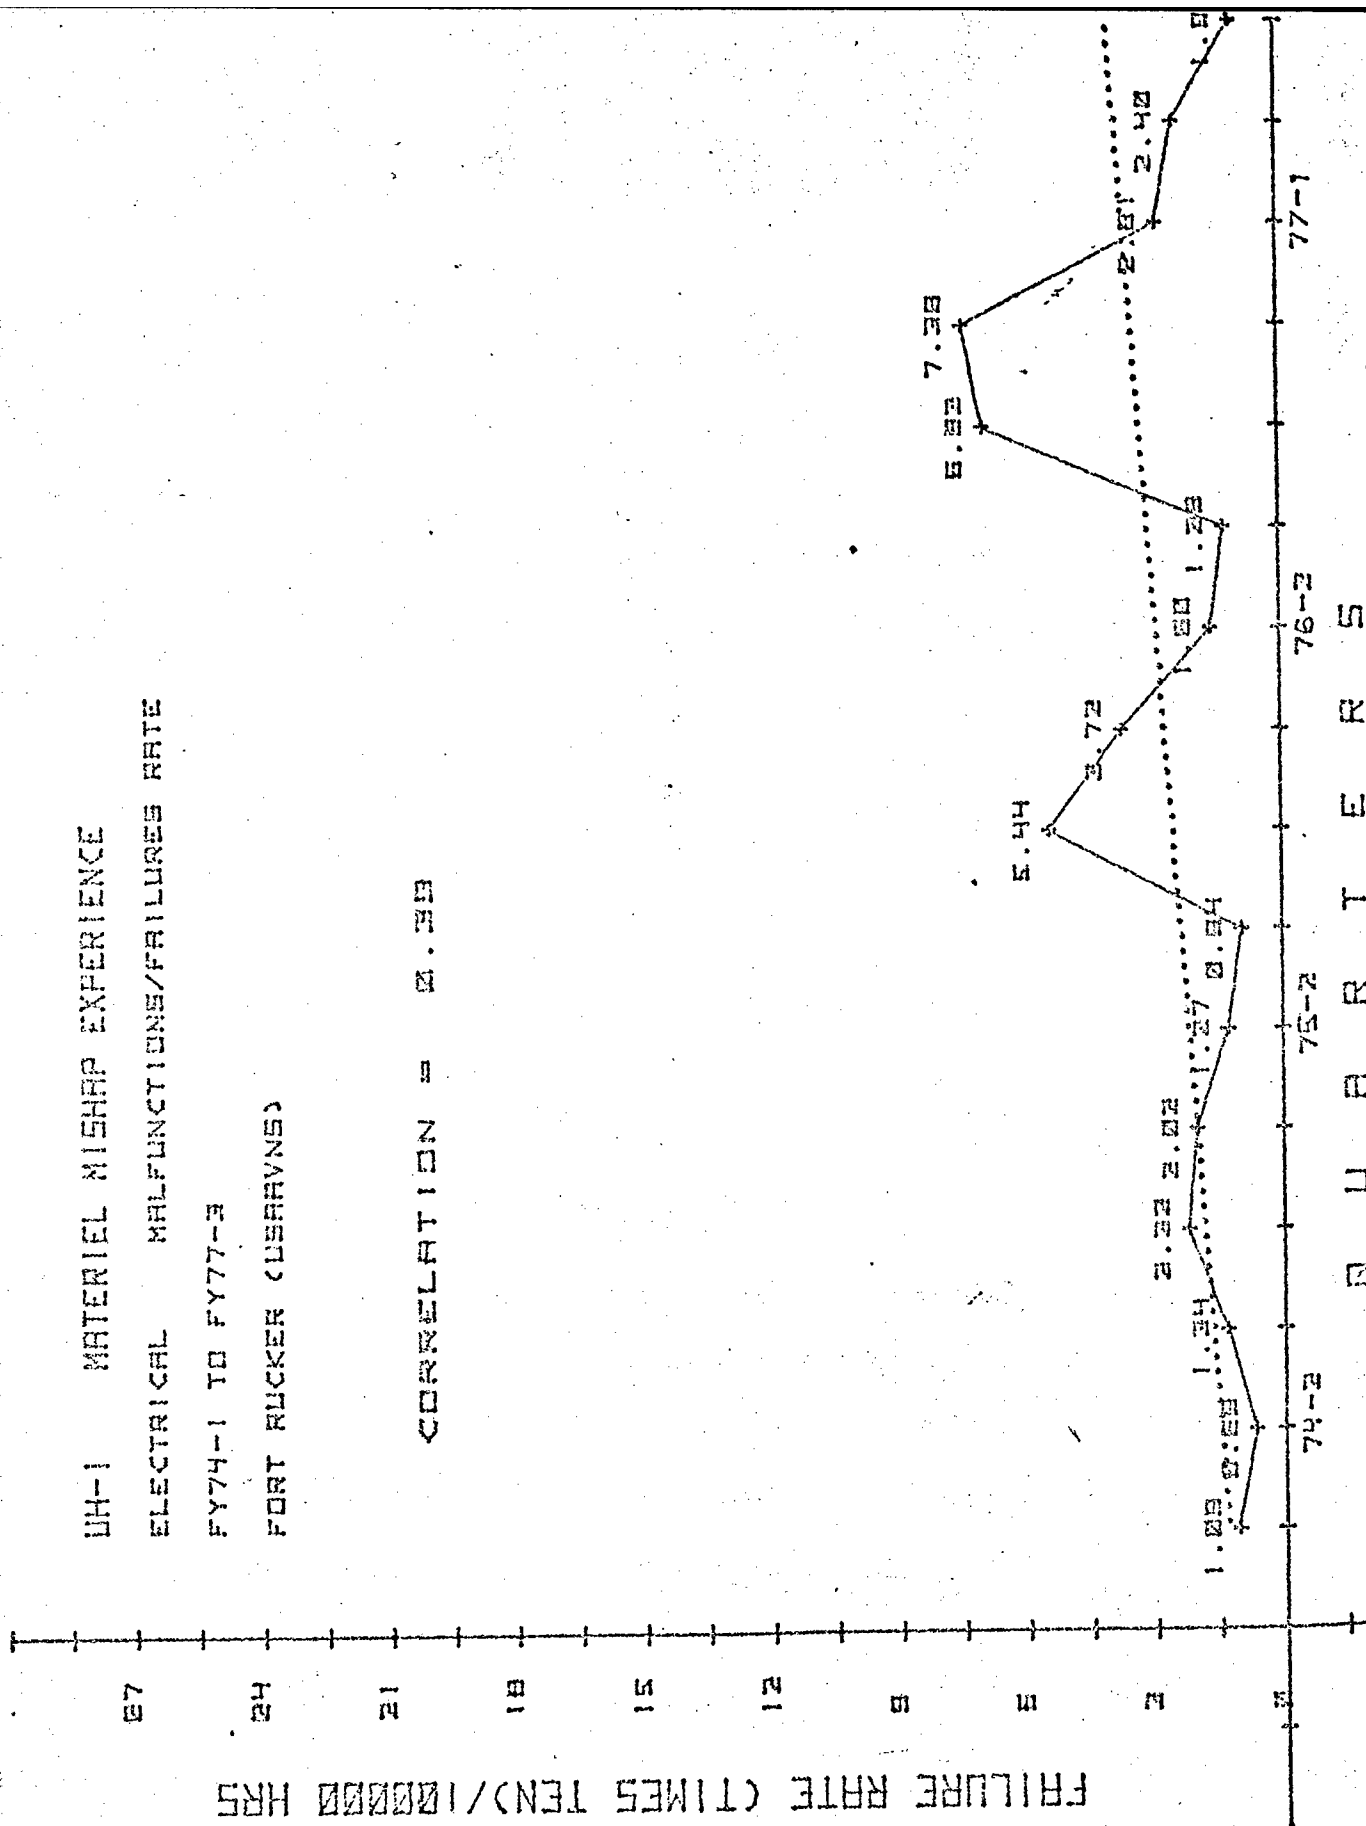
The electrical system malfunctions/failures were the cause of 126 or 17% of UH-1 materiel caused malfunctions. Figure 7 shows a significant increasing trend over the study period despite the last three quarters declining. The highest rate of 73.8/100,000 hours occurred in FY 7T quarter. The lowest rate of 6.9/100,000 was achieved in 2nd quarter FY 74. Electrical system materiel caused mishap for the entire period occurred at a rate of 24.8/100,000 hours. All the mishaps were precautionary landings.

FY 74-4 and FY 7T of Figure 7 indicates a sharp increase which also raises the total rate. This is due to the aircraft battery. In both of these quarters Fort Rucker experienced 14 battery malfunctions/failures. The other quarters in the study period only had 0 to 4 battery malfunctions/failures.

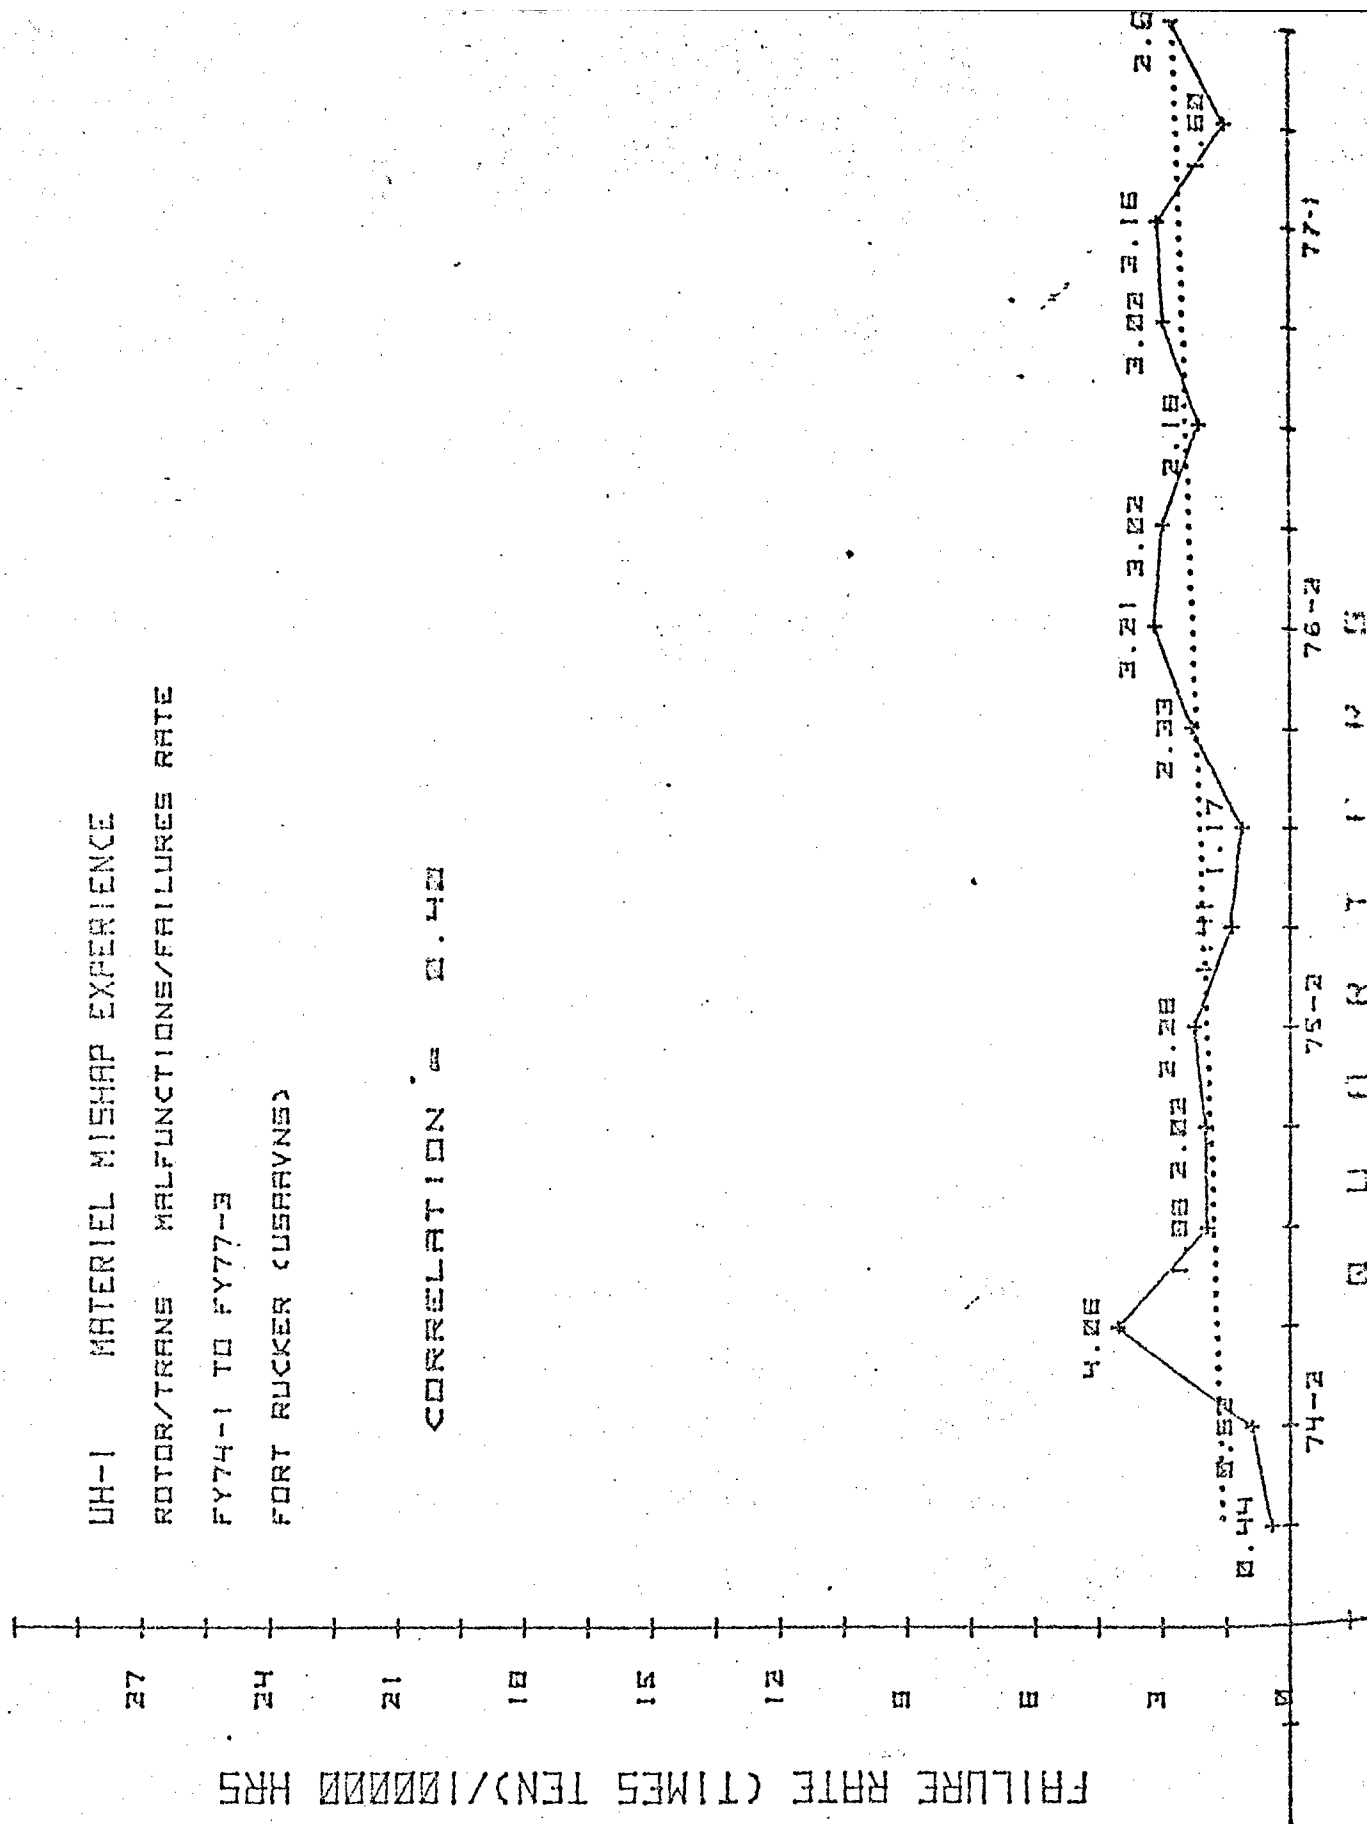
The rotor/transmission system malfunctions/failures were the cause of 112 or 15% of the 746 UH-1 materiel caused mishaps. Figure 8 showed

a slight increasing trend. The highest rate, 40.6/100,000 hours, was obtained in 3d quarter, FY 74. A 4.4 rate was obtained in 1st quarter, FY 74. Rotor/transmission materiel caused mishaps for the entire period occurred at a rate of 22.0/100,000 hours.

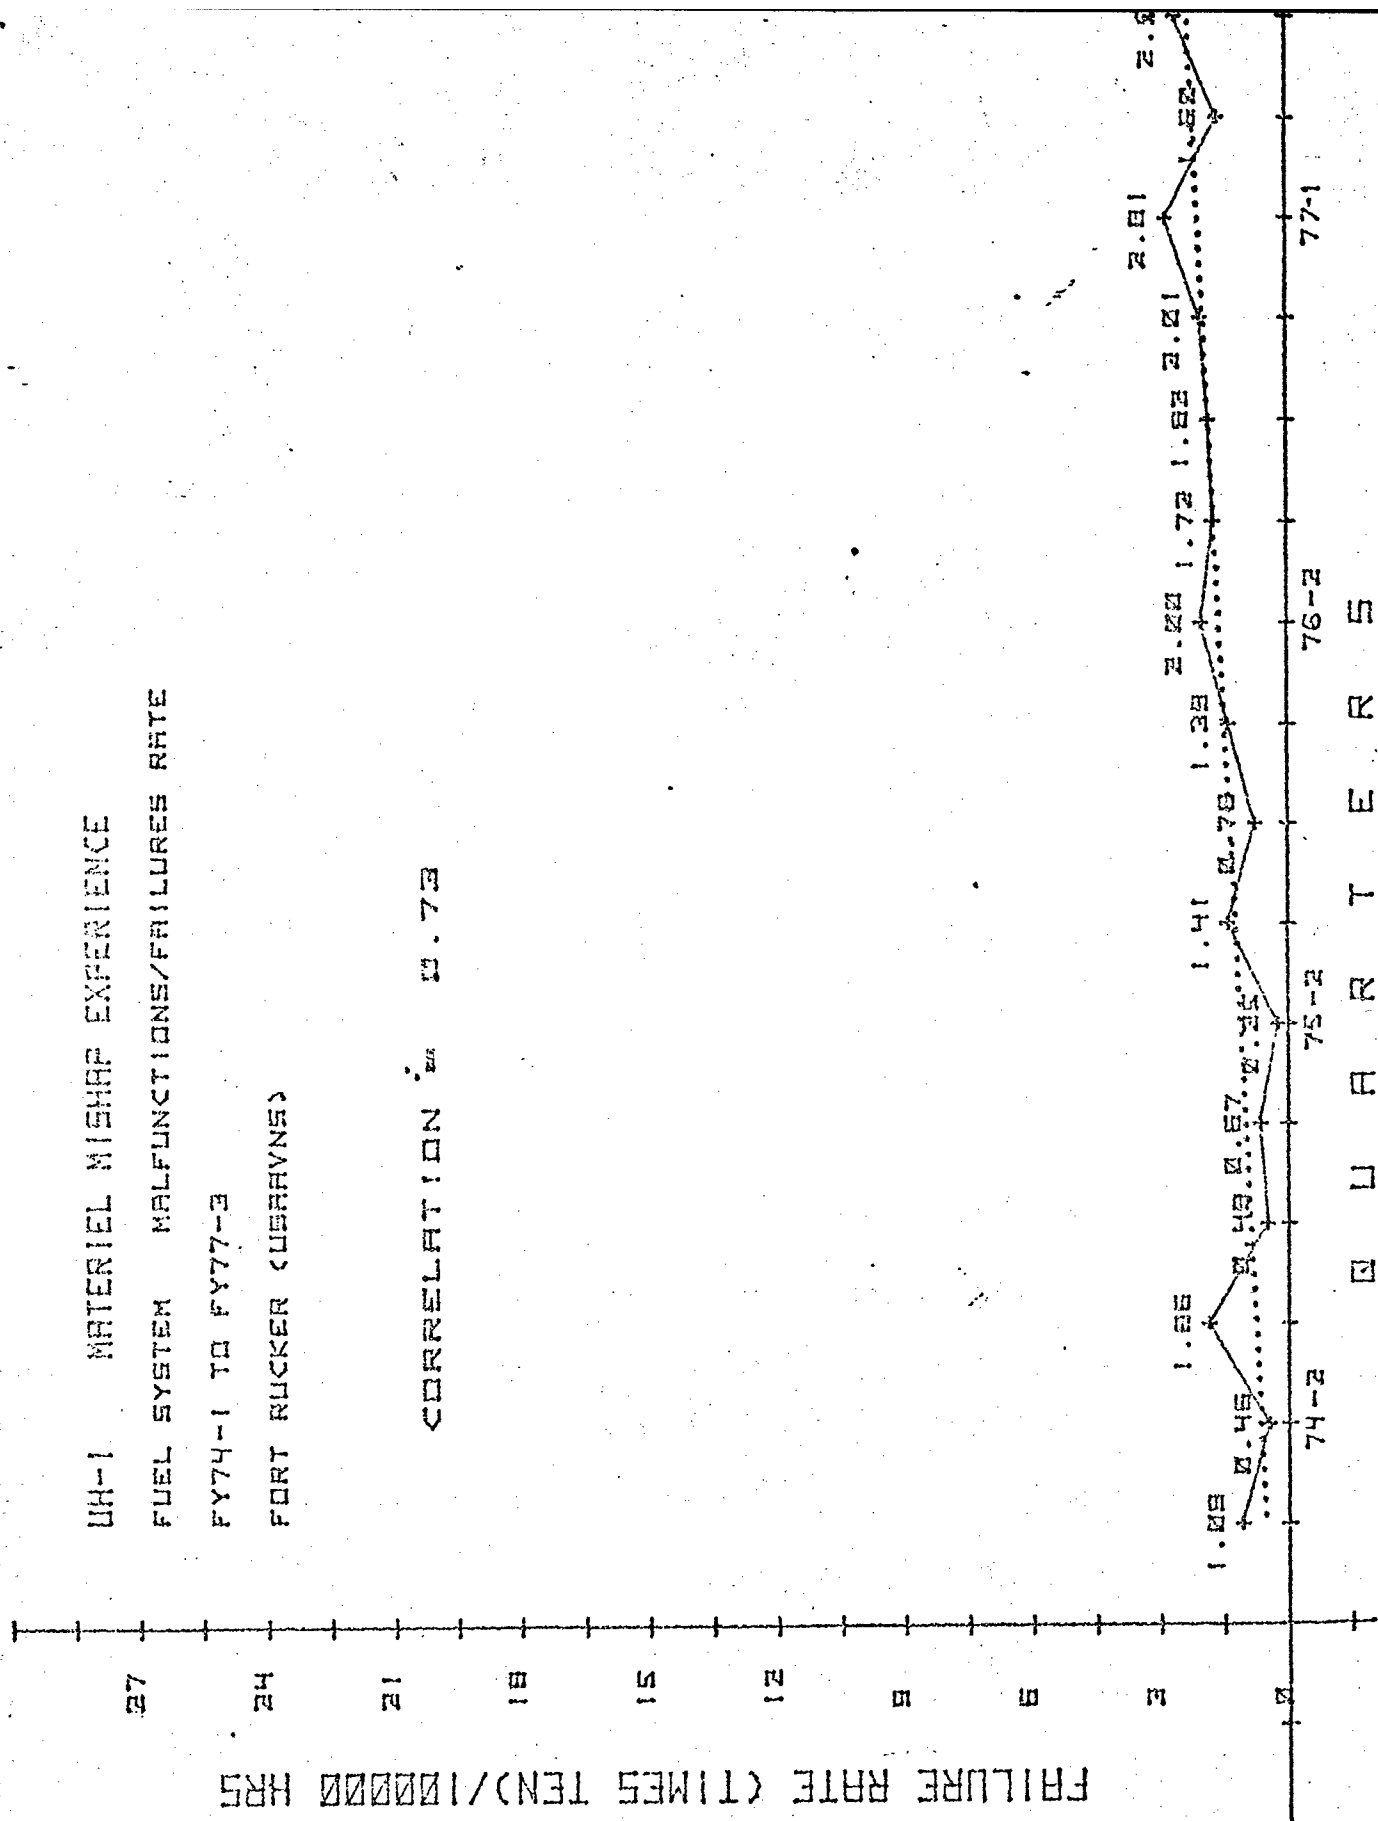
The fuel system malfunctions/failures were the cause of 70 or 9% of the 746 UH-1 materiel caused mishaps. Figure 9 shows a steady increasing trend. The highest rate of 28.1/100,000 occurred in 1st quarter FY 77. The lowest rate of 2.5/100,000 hours was achieved the 2nd quarter FY 75. Fuel system materiel caused mishaps for the entire period occurred at a rate of 13.8/100,000 hours.
